## **Progress with the Restoration of PK2613 Update No 9**

### **(1928 Trojan 3 Door Tourer ex Joe Pidgeon)**

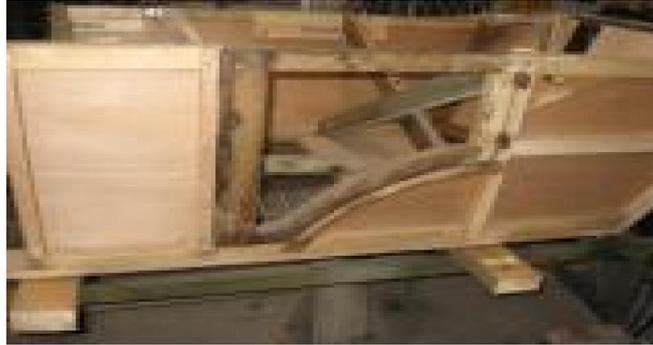
Trojan body tub braced for transport

Progress now took a dramatic turn for the better, previous snags with compound curves, door fits and closing details miraculously disappeared and in four weeks the tub was skinned in aluminium, fitted to the punt and the doors hung.

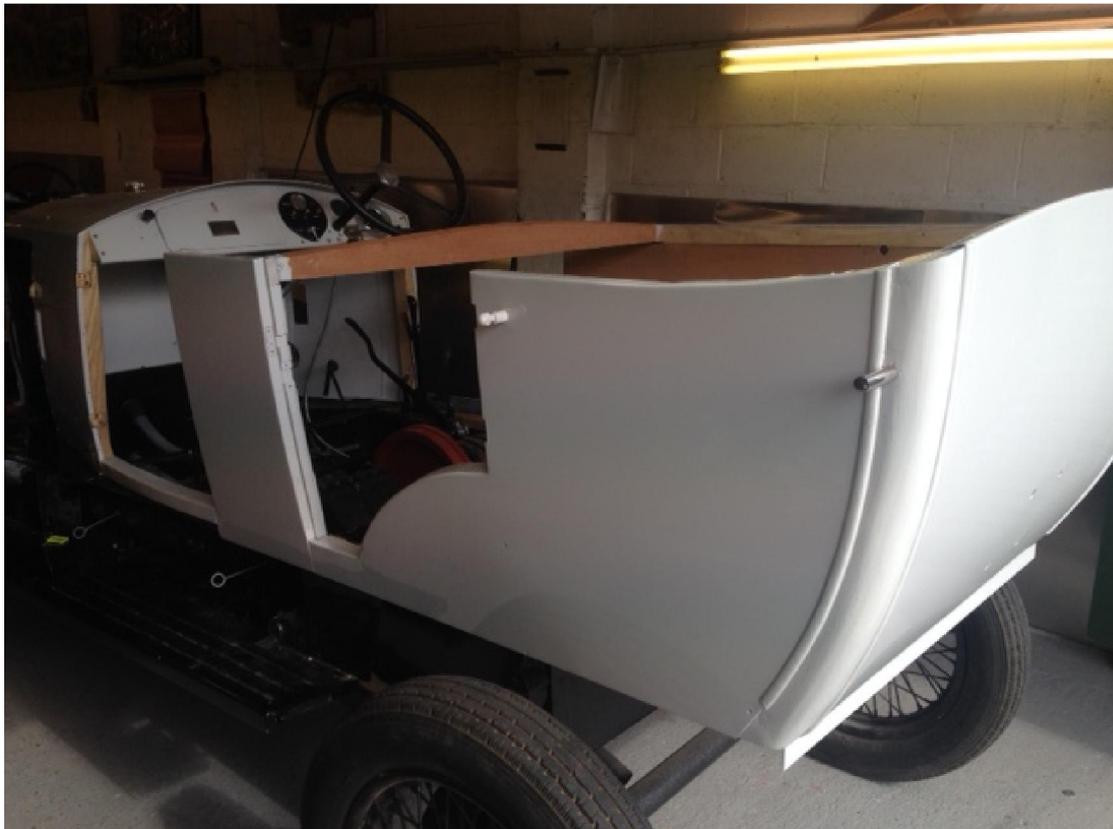
Trojan rear body tub awaiting wings and doors

There was a pause while the rear wings were blast cleaned, repaired and primed before being offered up to the body for final adjustments. The off side mudguard had been largely preserved by a mixture of oil thrown off the drive chain and mud; the nearside wing required major surgery and a new inner wing section to repair it. After a visit to the paint shop nearby the car was reassembled and for the first time for many years the full impact of a battleship grey body and black wings could be appreciated.

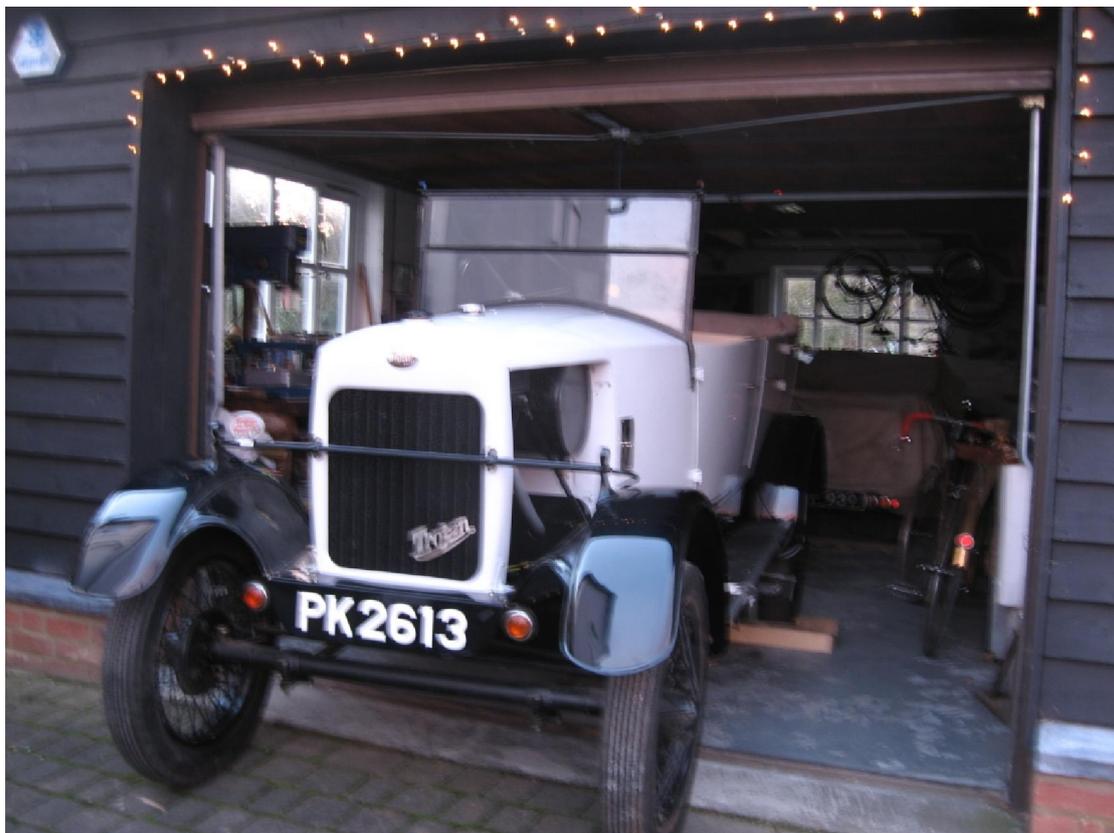
The Trojan takes a look outside in December

most Trojan owners will have observed the bottom rail has to accurately match the bonnet curvature and the palm ends on the uprights require a subtle twist which allows them to match the tapering cross section of the bonnet. After much head scratching I recollected Joe confessing that he had once rolled into a ditch having failed to negotiate a sharp right hand bend at the bottom of a hill. Hence the broken windscreen frame and bent uprights. The uprights are a fish belly pattern with a convex curve on one face and flat on the other. Careful examination showed them to be beyond the capability of my vice and cold bending. Assembling a portable forge in the garage was suggested but ruled out on grounds of lack of space and fire risk. Cold bending in a press against a template was considered but discounted as too time consuming with the logistics involved. At this point Phil Potter paid a visit on his way to Norfolk, realising that I had a serious problem with the available facilities in the workshop he offered to return with his oxy-acetylene equipment which would allow local heating and bending of the uprights. As good as his word three weeks later he returned and equipped with his gas torch he heated and bent each upright to achieve the desired fit. Just before Christmas the Trojan was able to take a peep out of the garage complete with windscreen.
